NEXA – NPWT System

A new and simple use of Disposable Negative Pressure Therapy

A new and simpler use of Negative Pressure Wound Therapy in treatment of 3 pressure ulcers and 1 leg ulcer

Sylvie Hampton and Sarah Gray, Independent Tissue Viability Nurse Consultants

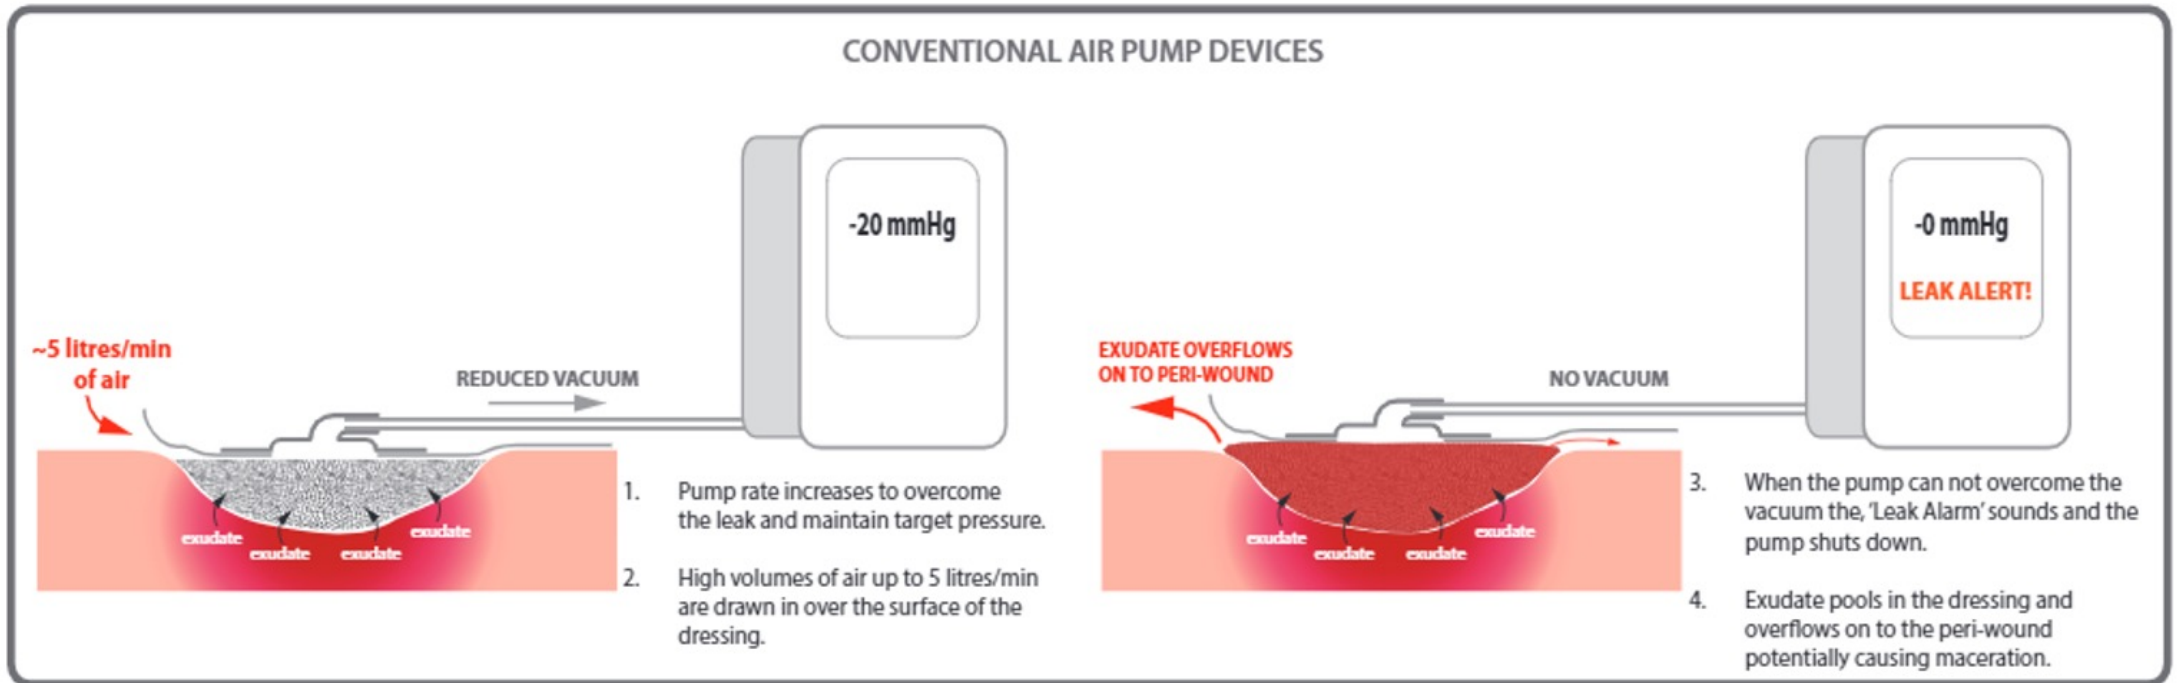
What happens in the case of leaks?

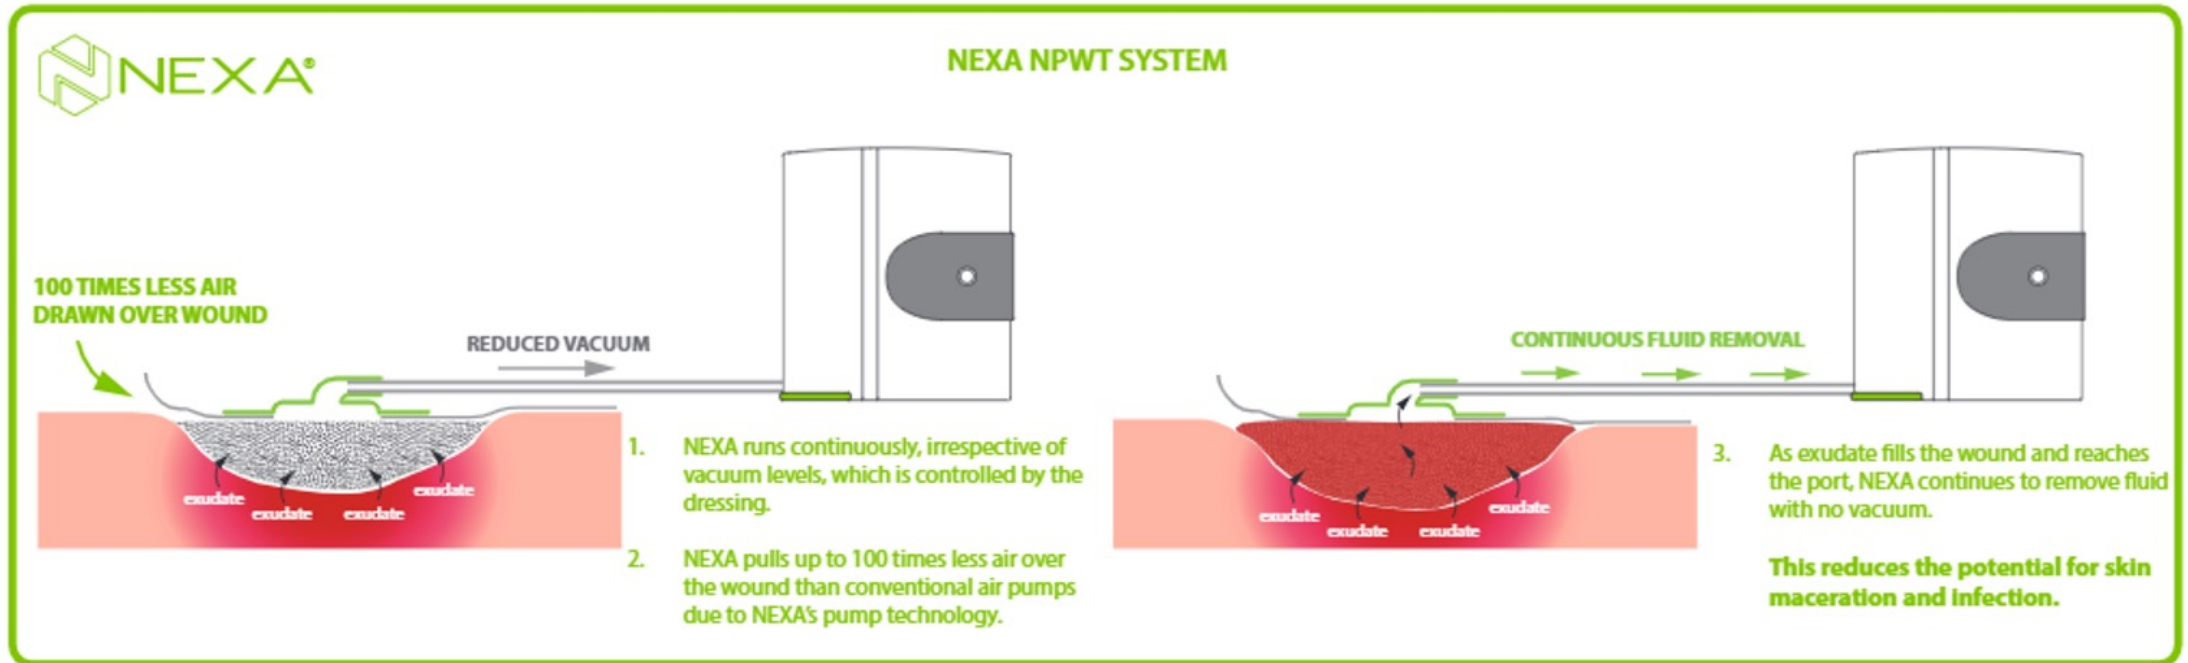
What happens in the case of leaks?

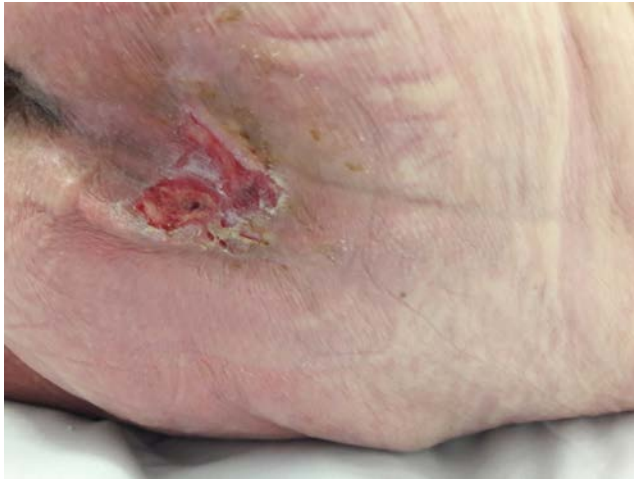
8th June 2019 The wound is deep and non healing.
Nexa is applied

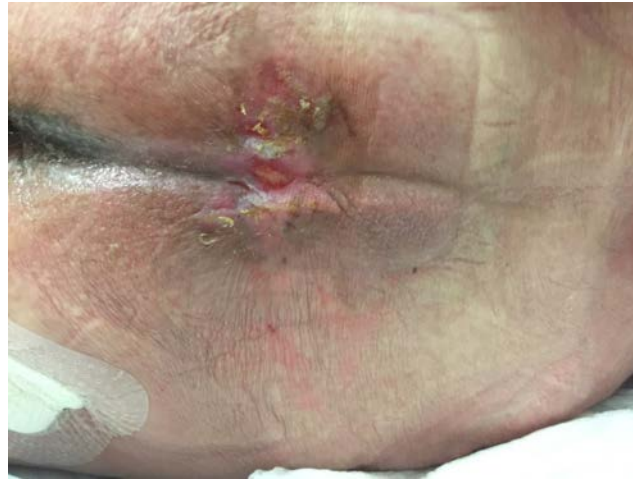
14th June 2019
The wound is clean, superficial and granulating.

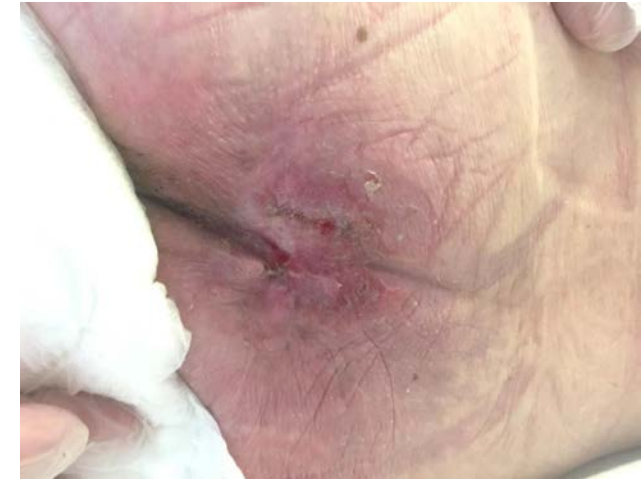
17th June 2019 The wound is clean, superficial, granulating and has almost closed. It is too small for Nexa to be applied

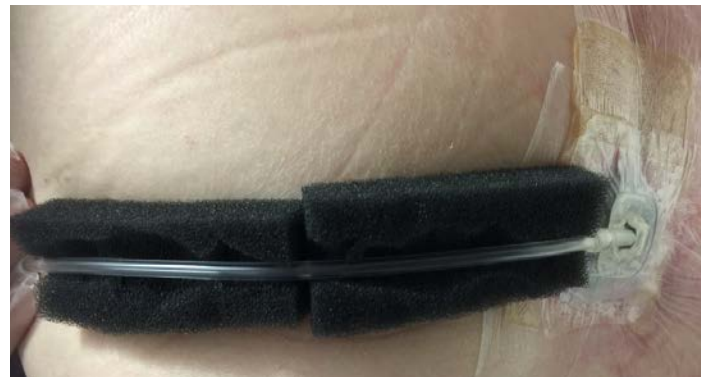
Nexa was easily applied. Some of the foam from the dressing was used to protect the skin. This was not essential, but this lady had particularly delicate skin.

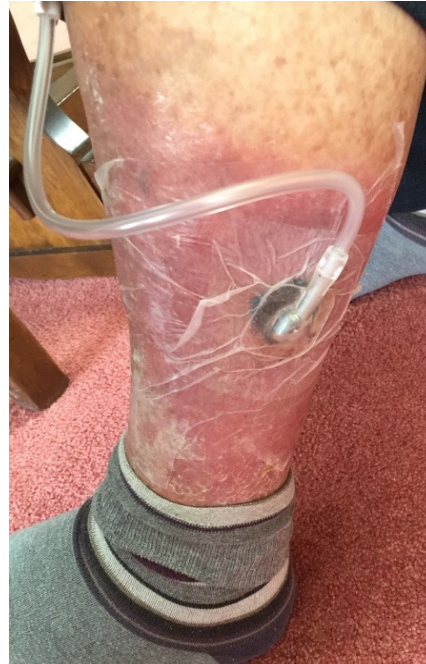
Nexa is situ

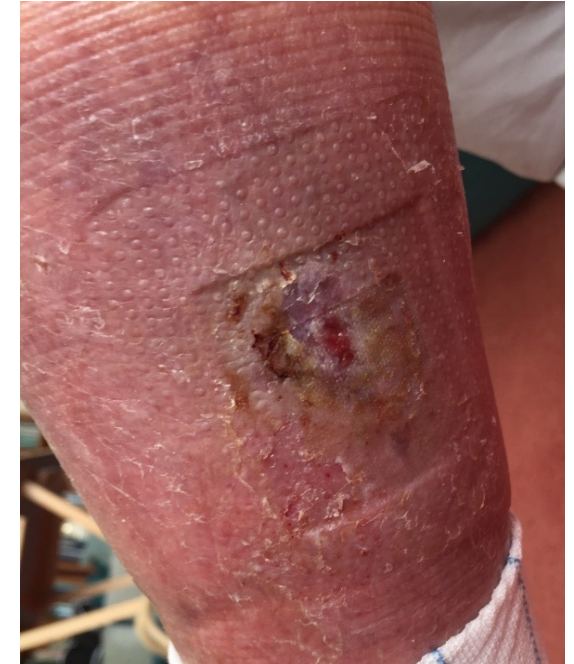
29th July 2019 The wound is too small for Nexa to be applied. It healed within the next seven days

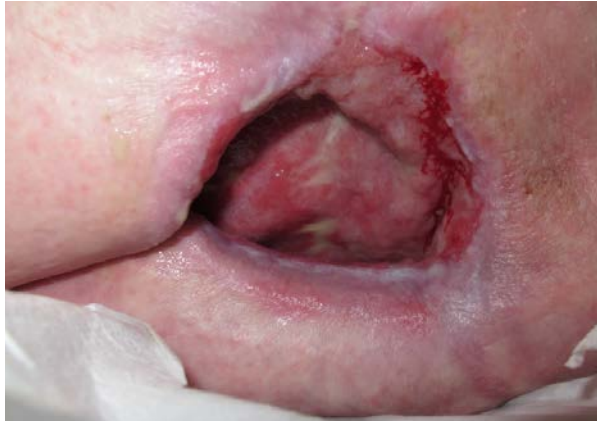
14th April 2019

The wound measured 12cm in diameter and extended down to the bone. There was 5cm of undermining.

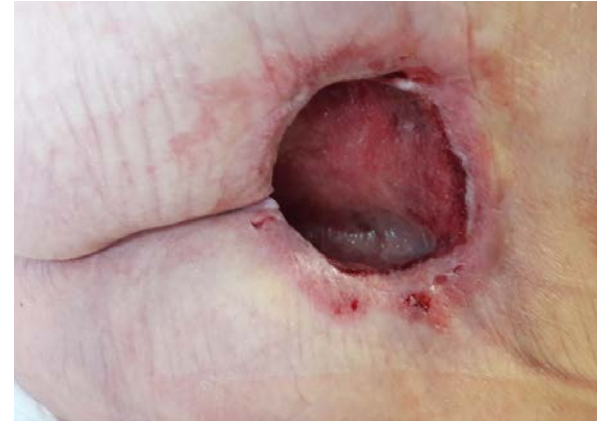
21st May 2019

The wound diameter had decreased by 3cm and the undermining by 3cm.

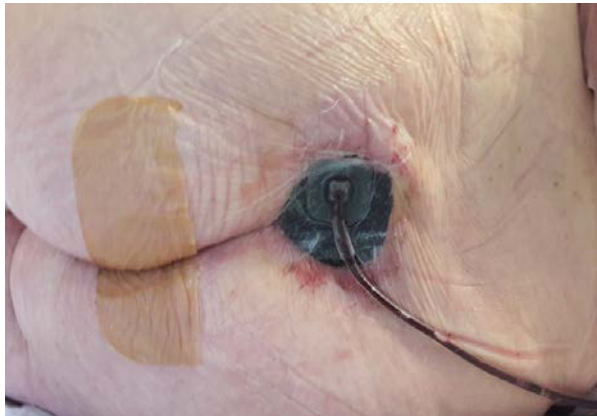
Nexa in situ. A hydrocolloid dressing was used to provide a barrier to faecal contamination.

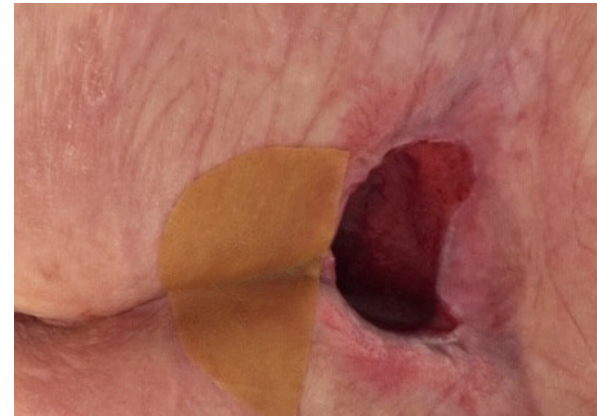
20th September 2019

The wound diameter had decreased by a further 5cm. There was no undermining.
